## TYPE 2 ASBESTOS MANAGEMENT SURVEY AT SABC054 - PC Main Road, Pontesbury

CLIENT: Shropshire Council

PROJECT NO: S09-06727

SURVEY START DATE: 24 November 2009

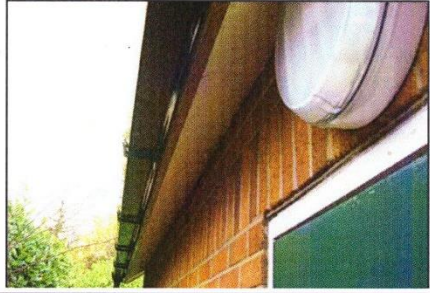
Building ID	Block 1			Item Location	Soffit board		
Sample No.	S003			Item / Material	Board		
Floor Level	External			Asbestos Type	No Asbestos Detected		
Room No.	003			Extent	-		
Room ID	Male Toilet						
MDHS 100 Material Scores:	Product:	-	Total Material Score:	Priority Scores:	Occupant Activity:		Total Priority Score:
	Condition:	-			Likelihood of Disturbance:		
	Surface Treatment:	-			Potential of Human Exposure:		
	Asbestos Type:	-			Maintenance Activity:		
Material Assessment Category:		-	Total Score (Material + Priority):		-	Risk Priority 1, 2 or 3:

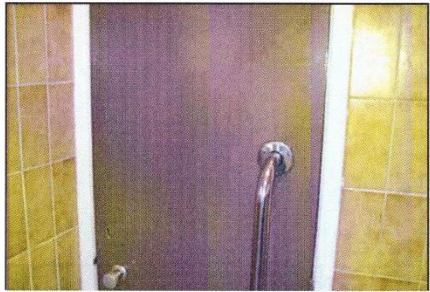
**No access was possible within Cleaners Store 002 as the keys supplied did not fit the lock.**

Building ID	Block 1			Item Location	No Suspected Materials Seen		
Sample No.	-			Item / Material	-		
Floor Level	Ground Floor			Asbestos Type	-		
Room No.	002			Extent	-		
Room ID	Cleaners Store						
MDHS 100 Material Scores:	Product:	-	Total Material Score:	Priority Scores:	Occupant Activity:		Total Priority Score:
	Condition:	-			Likelihood of Disturbance:		
	Surface Treatment:	-			Potential of Human Exposure:		
	Asbestos Type:	-			Maintenance Activity:		
Material Assessment Category:		-	Total Score (Material + Priority):		-	Risk Priority 1, 2 or 3:

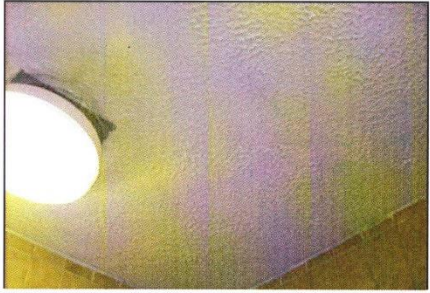
Building ID	Block 1			Item Location	Ceiling				
Sample No.	S001			Item / Material	Textured Coating				
Floor Level	Ground Floor			Asbestos Type	No Asbestos Detected				
Room No.	001			Extent	-				
Room ID	Female Toilet								
MDHS 100 Material Scores:	Product:	-	Total Material Score:	Priority Scores:	Occupant Activity:	-	Total Priority Score:		
	Condition:	-			Likelihood of Disturbance:	-			
	Surface Treatment:	-			Potential of Human Exposure:	-			
	Asbestos Type:	-			Maintenance Activity:	-			
Material Assessment Category:		-	Total Score (Material + Priority):		-	Risk Priority 1, 2 or 3:		-

Notes:					
				Recommendation:					
Potential For Hidden Asbestos:	Floor Voids:	-	Structural Boxing:	✓	Structural Voids:	-	Electrical Equipment:	-	
	Floor Ducts:	-		Dry Lining:		-		Electrical Equipment:	-
	Fixed Ceilings:	✓		Plant and Equipment:		-		Stud Walls:	-
	Fixed Seating:	-		Service Riser:		-			-

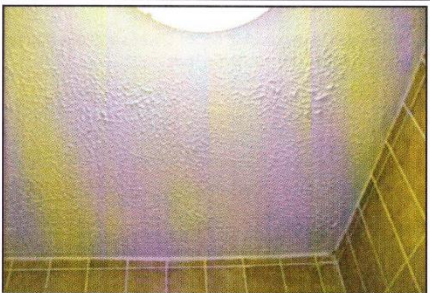
Building ID	Block 1			Item Location	Ceiling				
Sample No.	S002			Item / Material	Textured Coating				
Floor Level	Ground Floor			Asbestos Type	No Asbestos Detected				
Room No.	003			Extent	-				
Room ID	Male Toilet								
MDHS 100 Material Scores:	Product:	-	Total Material Score:	Priority Scores:	Occupant Activity:	-	Total Priority Score:		
	Condition:	-			Likelihood of Disturbance:	-			
	Surface Treatment:	-			Potential of Human Exposure:	-			
	Asbestos Type:	-			Maintenance Activity:	-			
Material Assessment Category:		-	Total Score (Material + Priority):		-	Risk Priority 1, 2 or 3:		-

Notes:					
				Recommendation:					
Potential For Hidden Asbestos:	Floor Voids:	-	Structural Boxing:	✓	Structural Voids:	-	Electrical Equipment:	-	
	Floor Ducts:	-		Dry Lining:		-		Electrical Equipment:	-
	Fixed Ceilings:	✓		Plant and Equipment:		-		Stud Walls:	-
	Fixed Seating:	-		Service Riser:		-			-
